EPA
LIBERIA

**A Full Scale Compliance
Monitoring at ArcelorMittal,
Liberia's Operation in
Yekepa, Nimba County**

Presented by
EPA's Assessment Team
To: The ESIA Technical Review Committee/Executive
Date: April 20, 2022

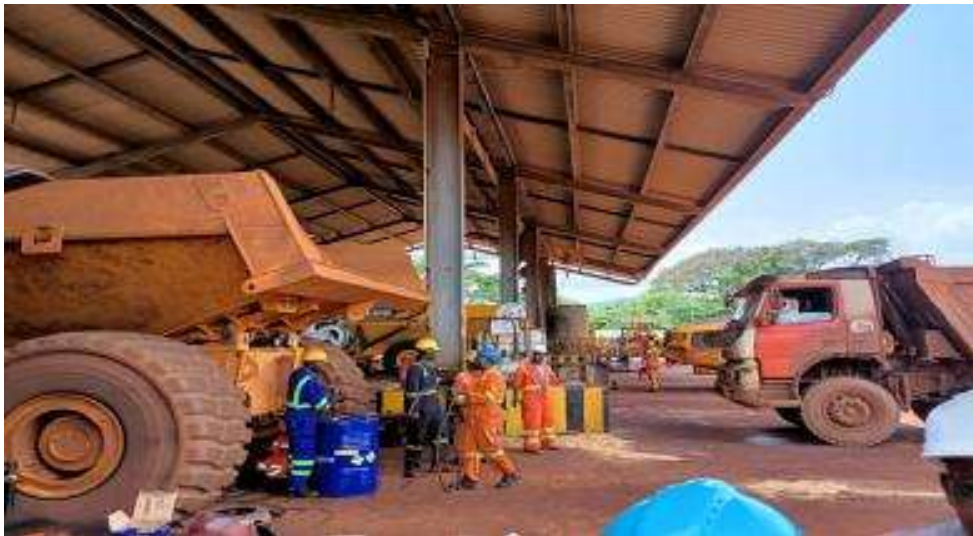
Point	Description	O ₃	PM ₁₀	CO	TVOC	CO ₂
AQ1	Workshop	0.01	20	90	0.0	2050
AQ2	Landfill	0.08	15	23	0.64	1450
	WHO standards	NS	50	50	0.75	5000

Workshop area

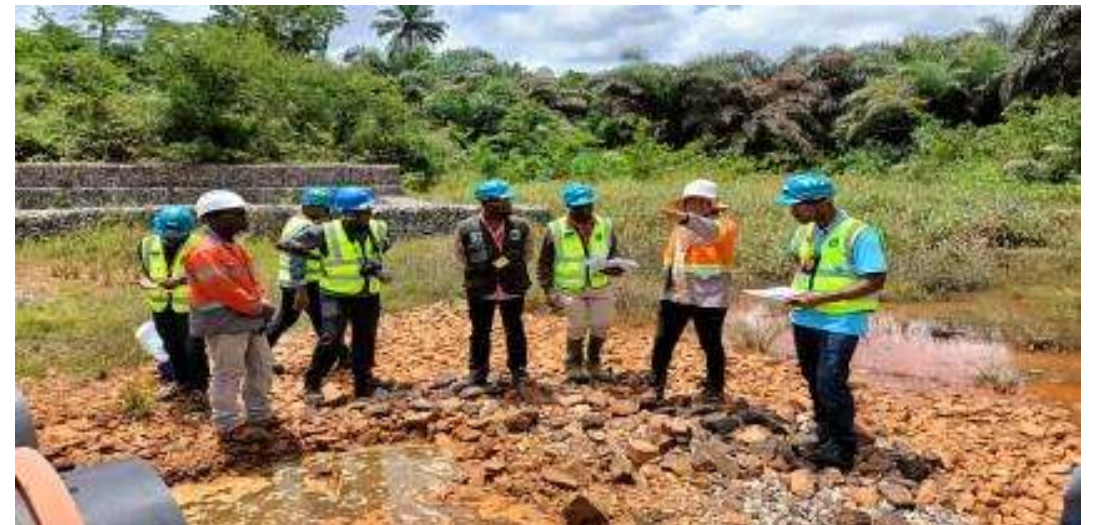
The results showed all but one parameter fell outside of both the WHO and the Class III of the Liberian Water Quality Standards. The only notable exception is Iron which recorded values above the required limit of the standards.

Inspection at Sedimentation ponds

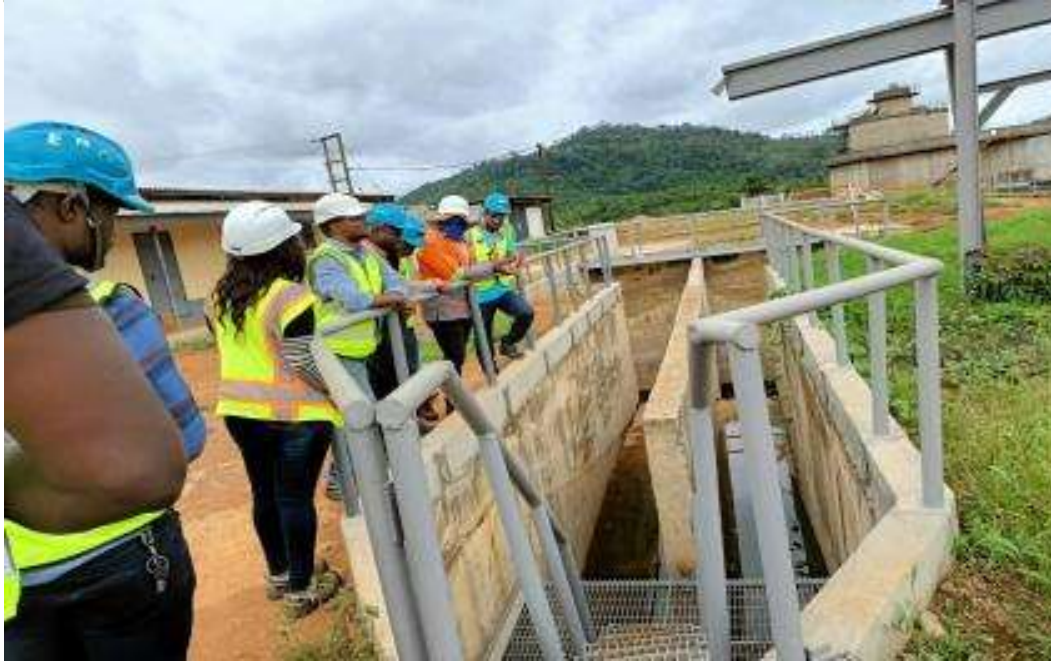
Proposed wastewater treatment: entry of the raw

- Ensure to conduct further assessment at the potential contaminated wetland to determine degree of pollution, at AML's cost;
- Ensure that AML desist from further use of the proposed wastewater treatment facility to avoid further pollution to the environment;

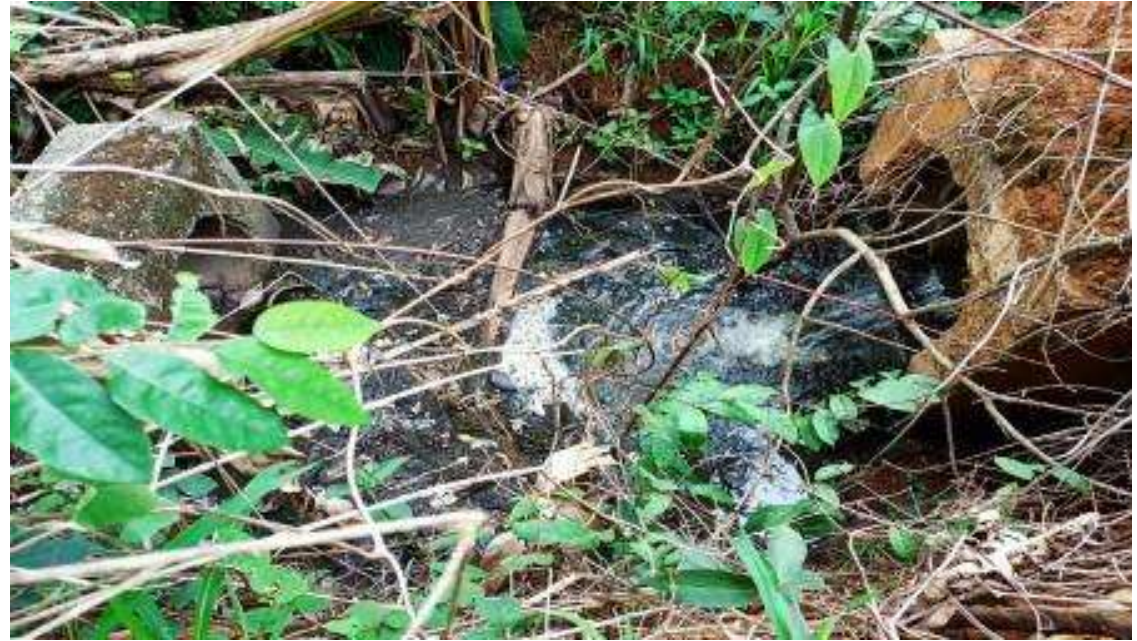
- Road leading from Yekepa to the mines is prone to accident as a result of dust storm, which hinders visibility for vehicle operators;
- No safety sign indicating one vehicle at a time was placed a single-crossing bridge for heavy vehicles transporting ore from the mines;
- Waste oil is being kept in a 5,000 L tank until further notice;
- Raw sewage was observed to be **directly discharged into the wetland** through the proposed wastewater treatment facility;
- The potential contaminated wetland serves as a tributary to a stream that empties into the **Deyea River**;

*Raw sewage from the wastewater treatment plant into
the wetlands*

- Ensure to communicate the necessary **fines** to the Management of AML for the deliberate action of polluting the environment which eventually could lead into a public health outbreak of water users downstream;

- The Management of AML shall be responsible to underwrite all costs associated with remediation to restore the environment;
- Ensure to name and shame the Management of AML for its action;

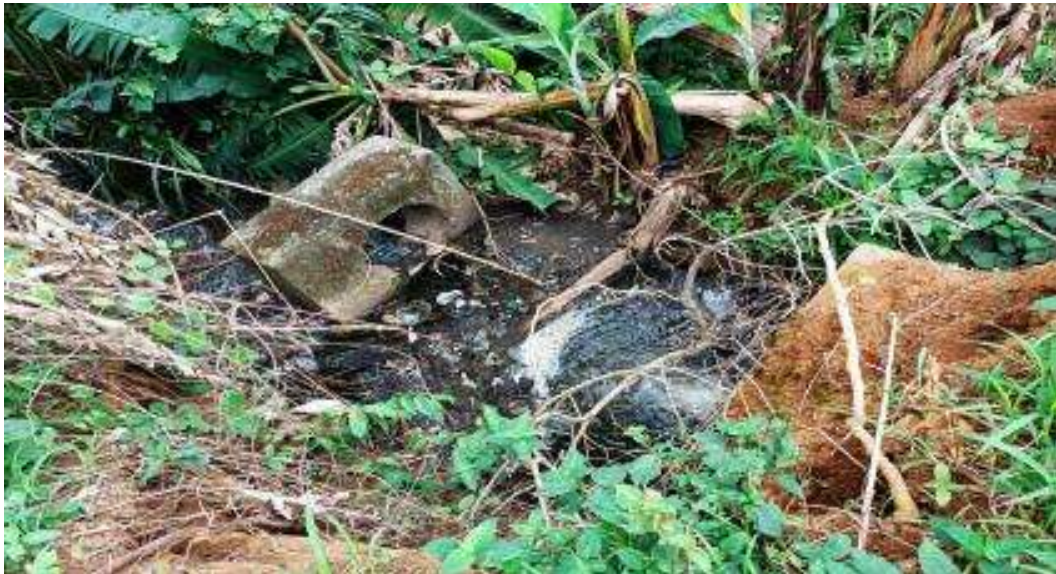
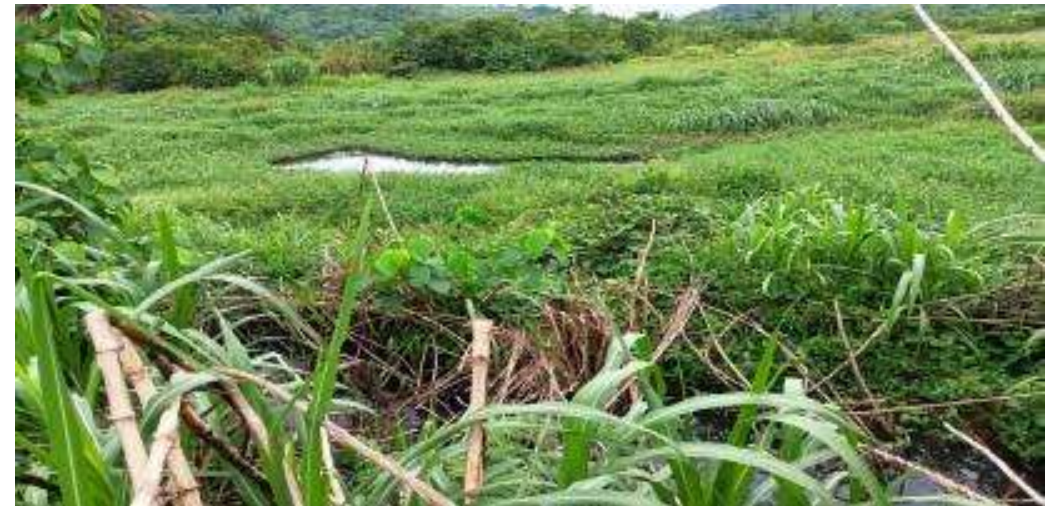
*Wetland
being
contamin
ated*

- Ensure to inform the local communities that are dependent on the water being contaminated, as early as possible, to prevent any public health issues as a result of consuming the potential contaminated water;

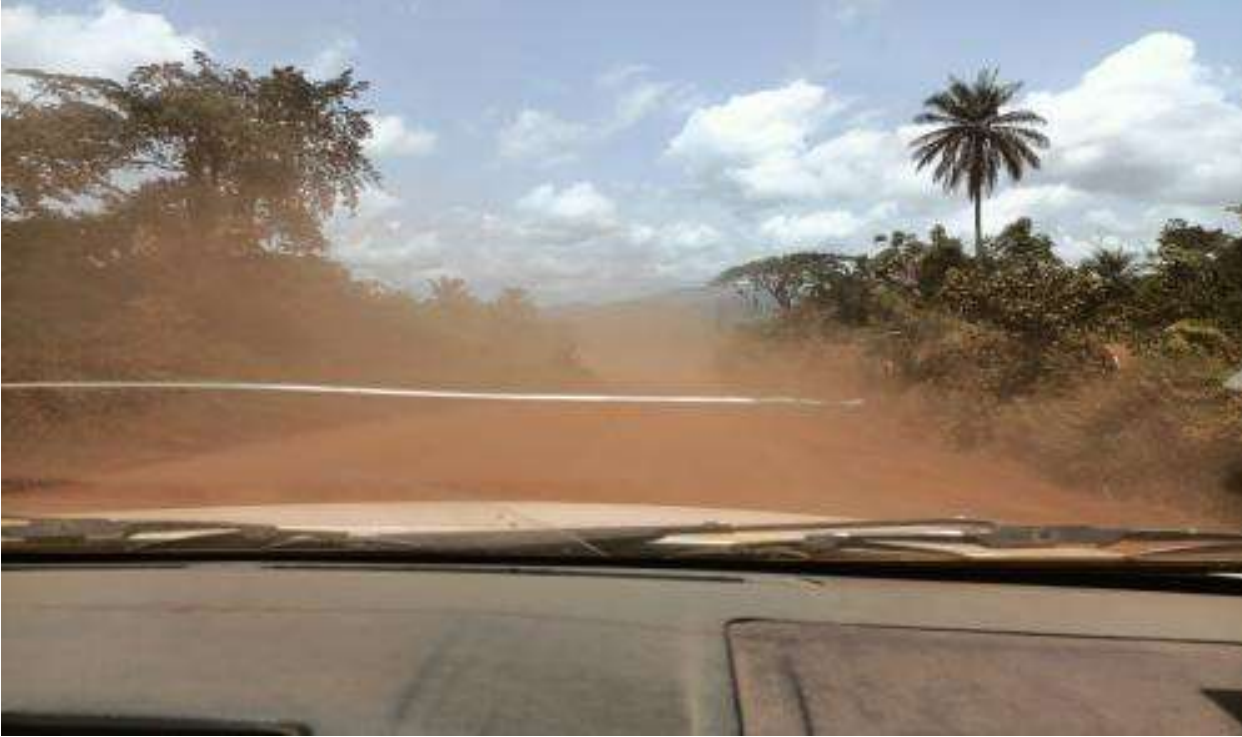
Dust storm along the mine road
