# Field Report of an Alleged Water Pollution from BMMC's Operation in NLGM, Grand Cape Mount County

Presented by  
The Investigation Team  
May 27, 2022

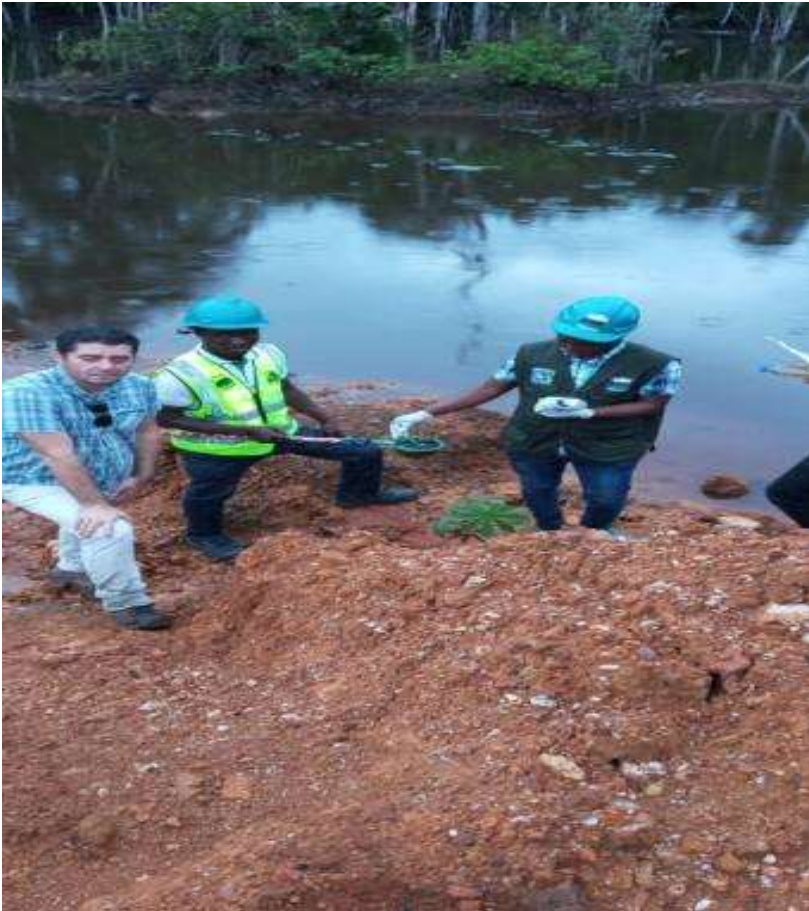
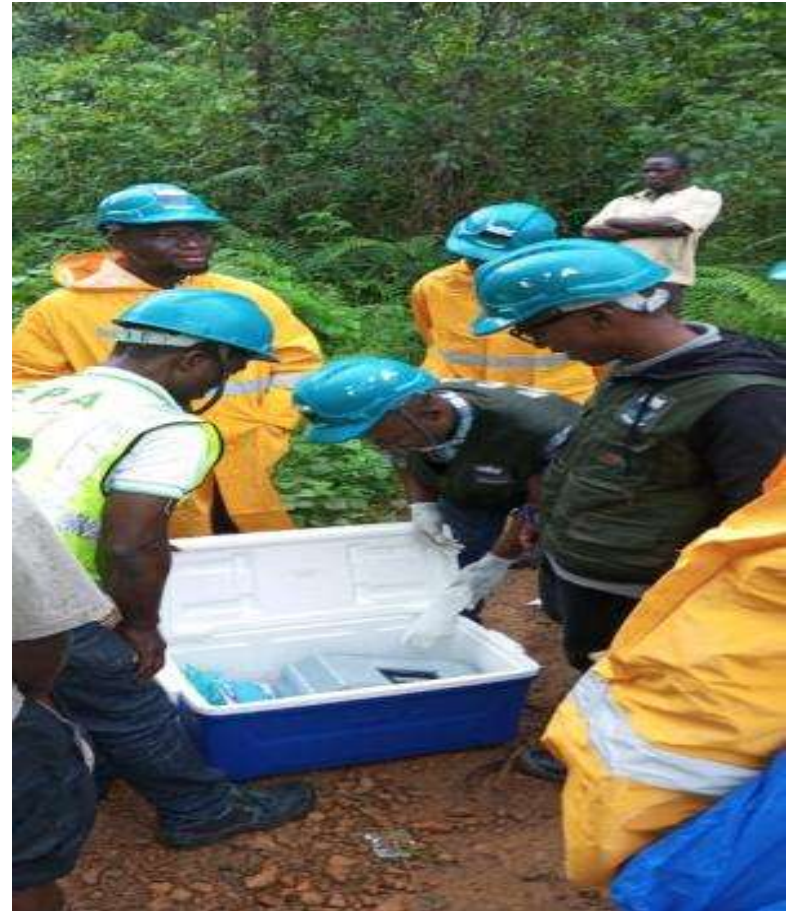
## FIELD SAMPLING

- Water samples were collected from 8 locations within the study area; duplicate samples were collected by BMMC for internal analysis;
- Samples were collected from upstream (Penstock 6), midstream (EDMP-2) and downstream of the TSF, using the grab technique. In situ readings were taken;
- Samples were collected into pre-treated sample bottles, labeled for easy identification and sealed.
- The samples were kept in ice chest with freeze packs.
- Appropriate chain of custody forms were completed in line with the Agency's standard for documentation of samples.
- All samples were transported to the EPA laboratory for analysis
