INVESTIGATION REPORT FOR RITCO AND BEST AGRICULTURE INDUSTRY

1.7 Date of current inspection: June 22, 2023

1.8 Type of inspection: Investigation

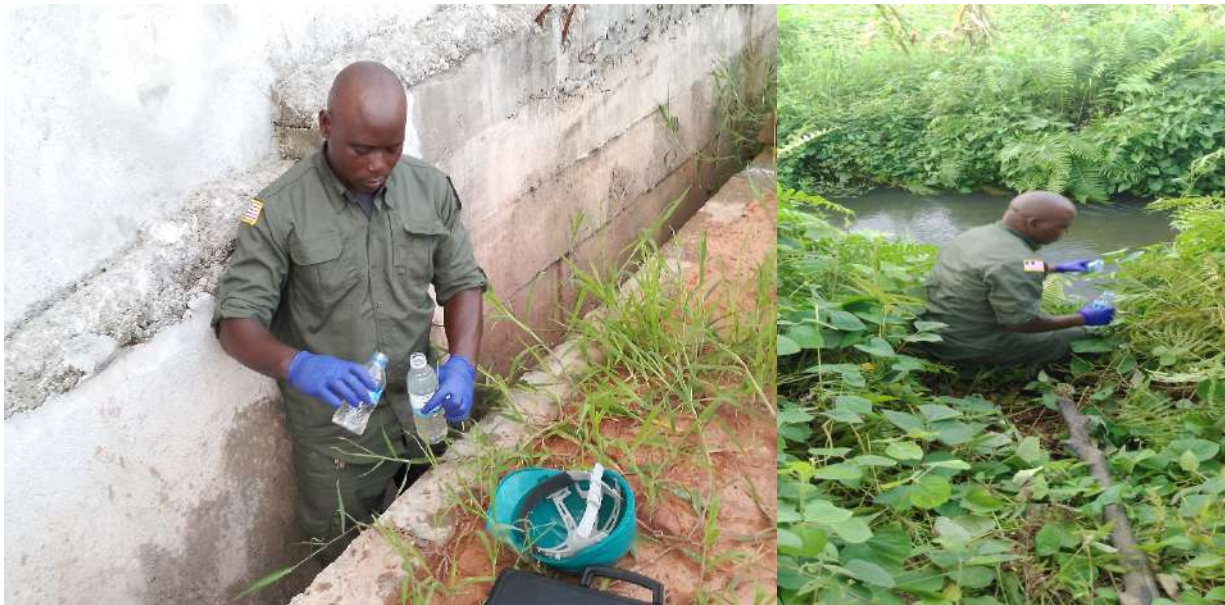
Plate 1: EPA Technician collecting water samples at the Back of RITCO in Lofa Community

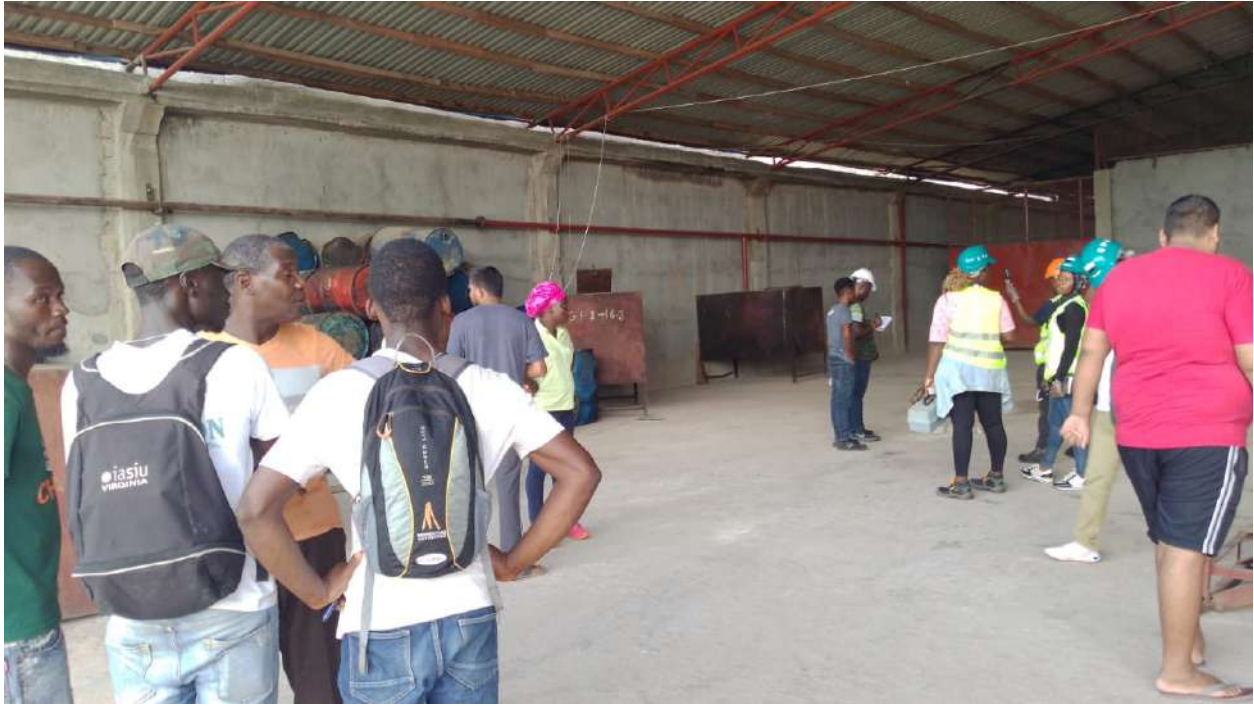
6. BAI has started full operation about six months ago.
7. Used oil recycling Factory is fully operational that produced wastewater with a frantic odor.
8. Wastewater from the production process is stored in an empty tank inside of the operation, but no management procedure in place at the moment.
9. Used oil was found spilled in storage area but covered with saw dust.

Plate 2: Investigation team along with RITCO, BAI and Community Representatives during investigation at BAI Used Oil storage Area

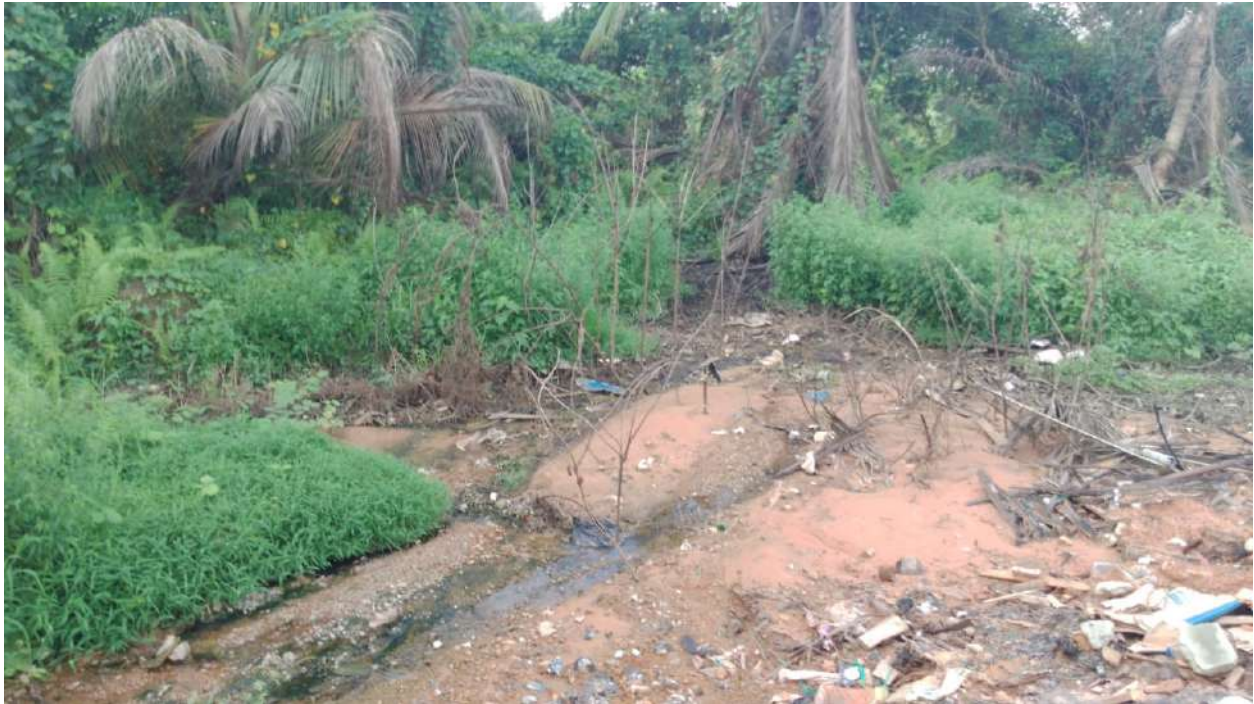
1. Protesters (mostly youth) from Lofa Community were found at the entry of RITCO and Best Agriculture facilities.
2. RITCO and BAI met with the community in a meeting in Clara Town and an understanding was reached to invite EPA to independently probe the matter.
3. There is a standing unresolved conflict between community and RITCO.
4. There was a wastewater channel observed at the back of RITCO-discharging effluent into nearby stream.
5. Vegetation was dying at the discharged point of the wastewater into the environment.

Generally, the results showed elevated levels or out of range values for all parameters analyzed for the two sampling points except copper and cadmium suggesting that the water from the sampling points is not suitable for human consumption and domestic purposes.

Plate 3: Effluent discharge point at the Back of RITCO and BAI

R1	Recommendation: EPA engages the parties involved to amicably resolve the matter
R2	Recommendation: RITCO upgrades its storm and wastewater management plan and submit same to the EPA
R3	Recommendation: BAI develops and submits to the EPA emission management plan for the used oil factory

R4	Recommendation: BAI obtains effluent discharge license for wastewater generated in the production plant
R5	Recommendation: BAI Upgrades pollution control measures to minimize emissions of pollutants into the air
R6	BAI Implements regular monitoring and maintenance programs to ensure that emissions from the factory are minimized

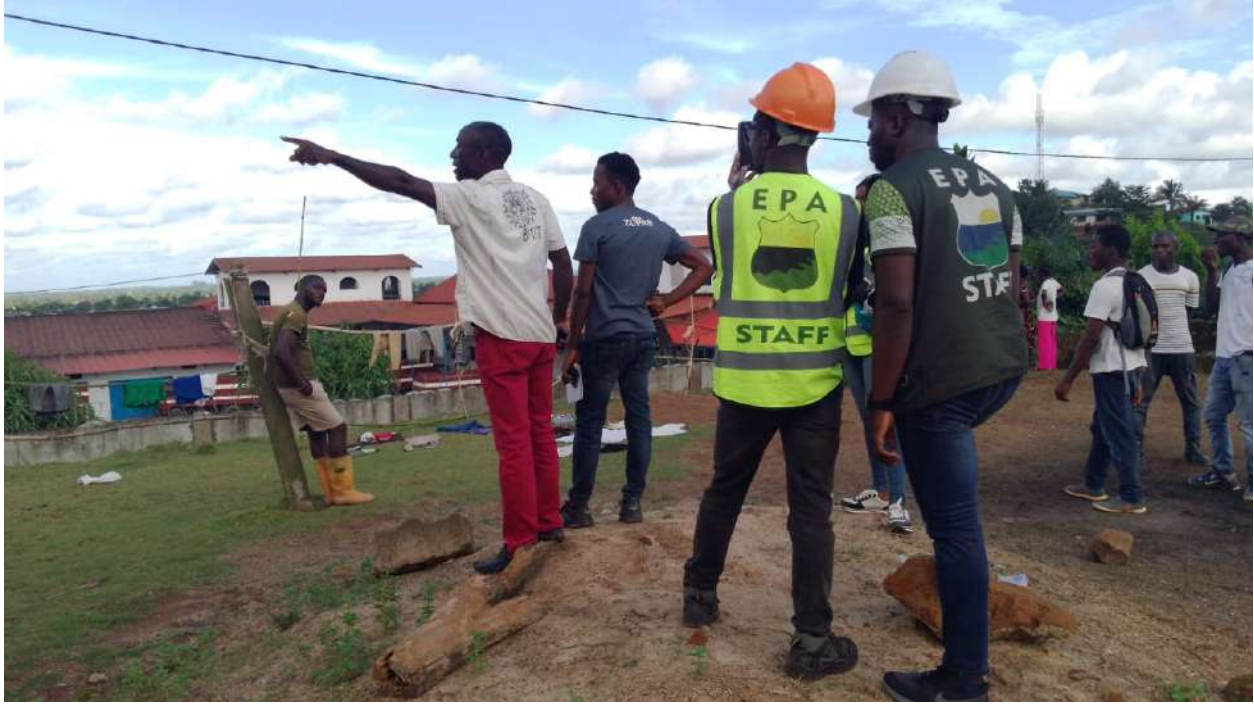
Plate 4: EPA investigation team conducting air quality reading at Ma Yunpu Residence, Block C, Lofa Community
