**Biodiversity Action Plan (BAP)  
Buchanan–Cestos City Junction Road Corridor (60.9 km)  
Mano River Union Road Development and Transport Facilitation Programme  
(MRU/RDTFP)-Liberia**

**Version 1.0 – For Submission to AfDB**

**Date: January 23, 2026**

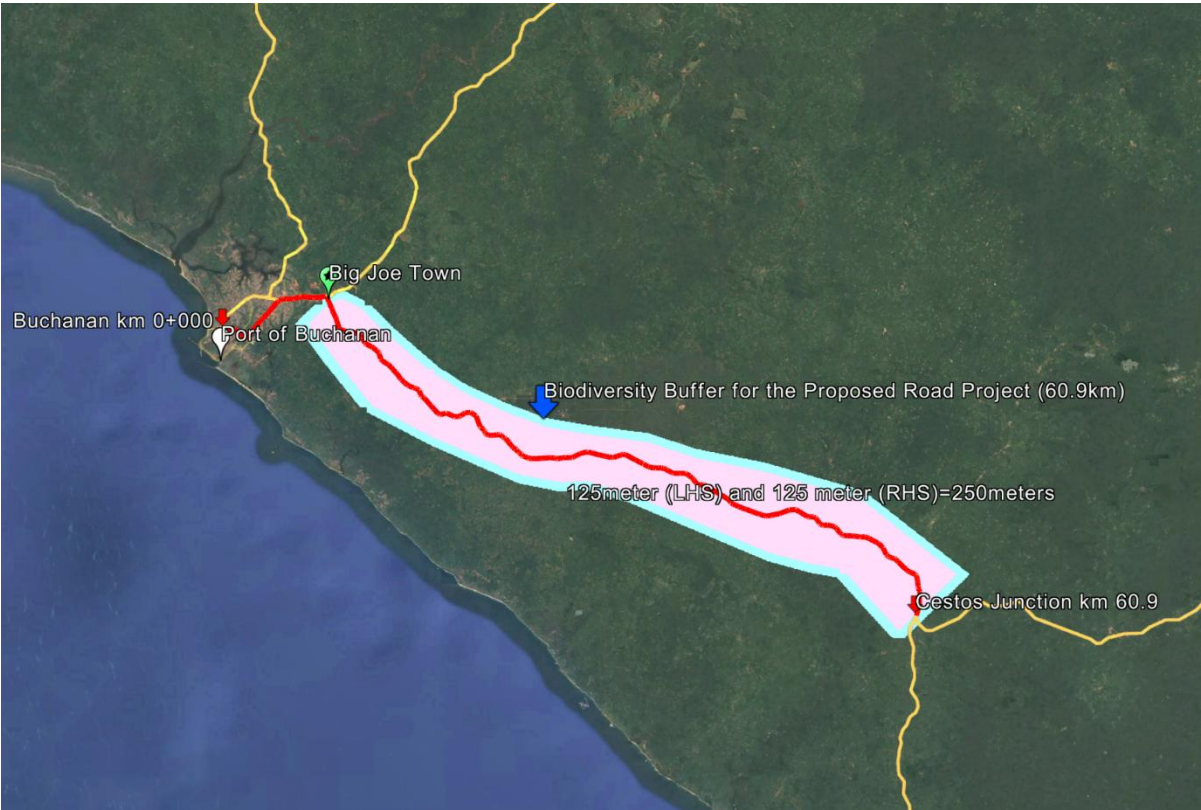
Figure 3: Map highlighting the biodiversity buffer of the proposed project area

of 250 meters consistent with the ESIA. The 250-meter AoI defines the assessment and management boundary; actual physical disturbance is confined to the approved ROW and defined engineering work sites. All biodiversity management and monitoring measures defined in this BAP apply within this 250-meter corridor. Field verification visits were conducted along representative sections of the corridor to confirm current land use conditions, habitat characteristics, and ecological features within the defined Area of Influence.

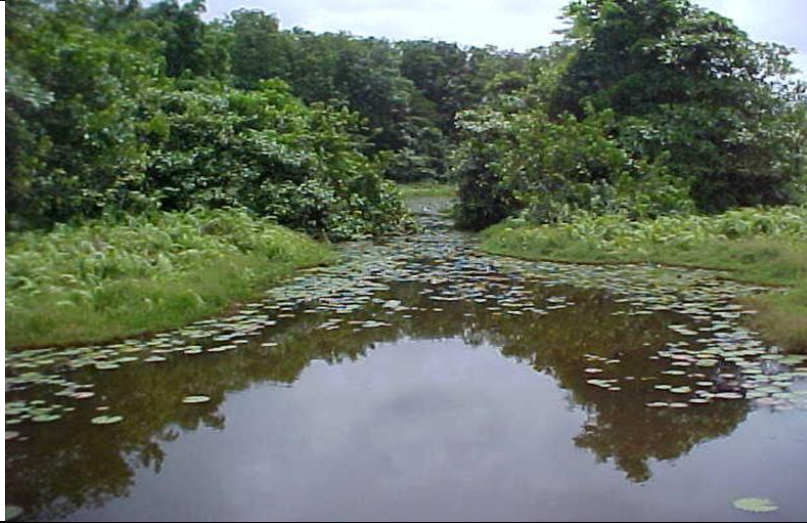
*Wetlands with Water Hyacinth along Benson River near Buchanan City*

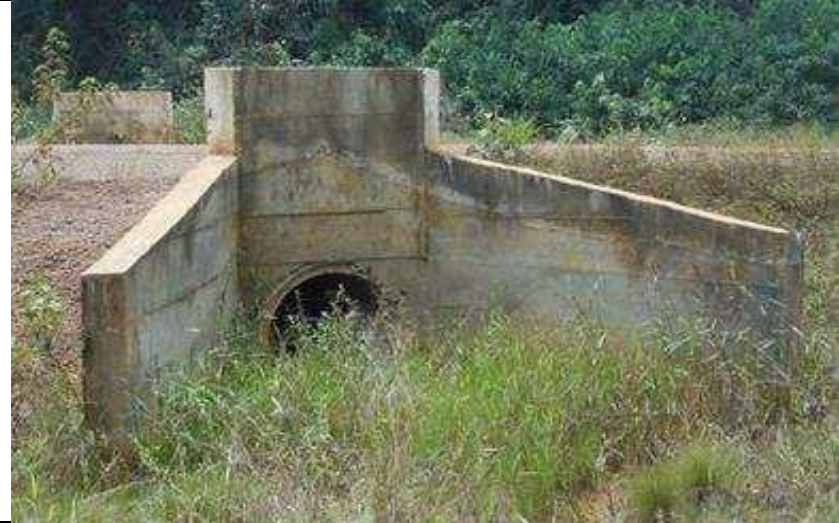
Existing drainage structures along the Buchanan–Cestos corridor showing reinforced concrete and culvert drainage systems, some of which are partially obstructed by vegetation and sediment, potentially affecting water flow and aquatic habitat conditions

Failure to maintain culverts at SC-01–SC-08 and drainage channels near WD-01–WD-06 could result in localized blockage and altered water flow. Routine inspection and maintenance during operation are required to sustain hydrological continuity. Properly functioning drainage systems are expected to reduce long-term erosion compared to existing gravel conditions.

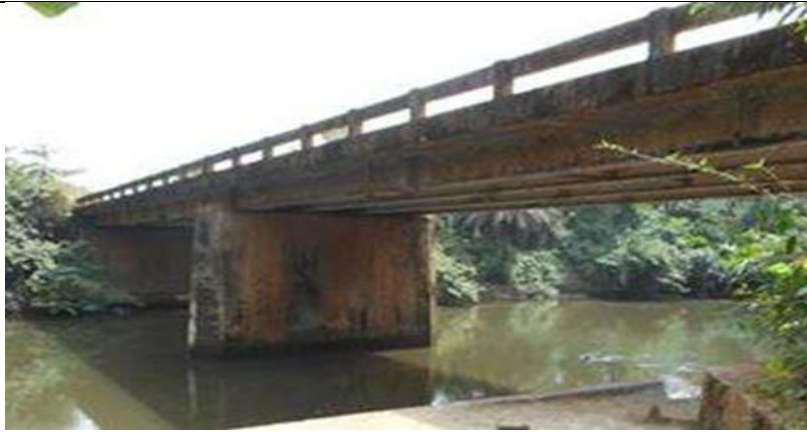
*Reinforced concrete beam bridge at km 14+200 crossing the New Cess River along the Buchanan–Cestos corridor, illustrating an existing river crossing where aquatic habitat connectivity and sediment control are key biodiversity management considerations.*

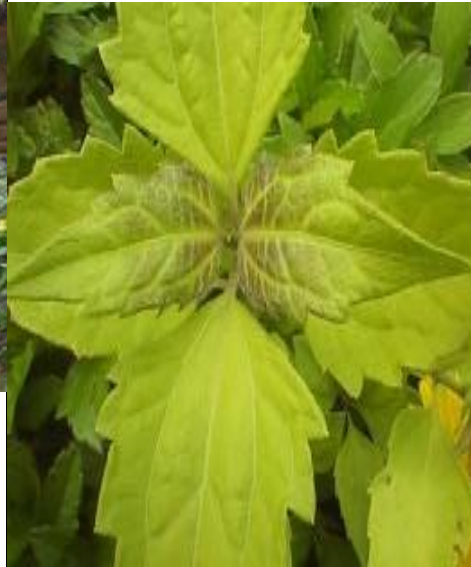
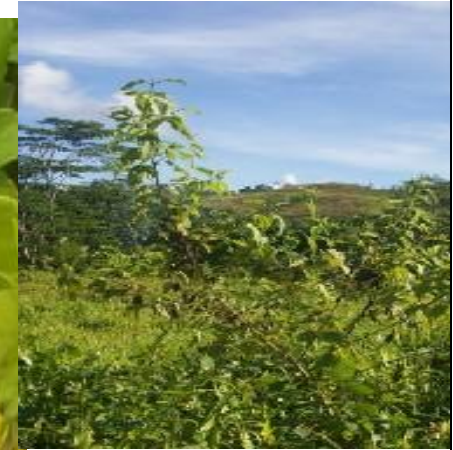
*Chromolaena odorata (Siam weed), an invasive plant species commonly colonizing disturbed roadside and fallow areas within the project corridor and potentially affects native vegetation regeneration during post-construction restoration.*

| Ecological Node | Activity | Quantity Basis | Unit Rate (USD) | Subtotal (USD) | Performance Indicator | Responsible Entity | Funding Source |
|---|---|---|---|---|---|---|---|
| | Invasive control | 4 ha | 1,500/ha | 6,000 | No dominant invasive regrowth observed | Contractor | Works Contract (BOQ) |
